U.S. Chemical Safety and Hazard Investigation Board

Seven Key Lessons to Prevent Worker Deaths During Hot Work In and Around Tanks

Effective Hazard Assessment and Use of Combustible Gas Monitoring Will Save Lives

No. 2009-01-SB

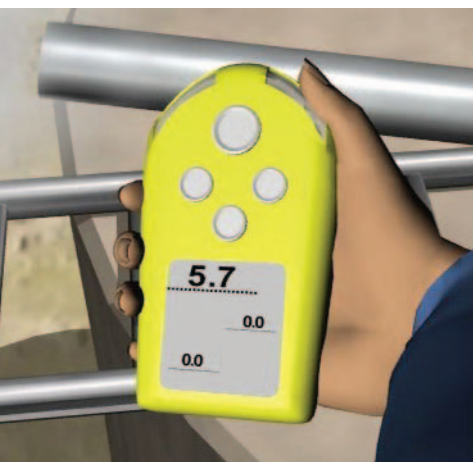
Example of a combustible gas detector used to test for the presence of flammable gas or vapor.

Flammable gas and vapor concentrations are generally determined using a portable combustible gas detector, also called an LEL.³ meter. Combustible gas detectors are relatively inexpensive and widely available. Training in LEL instrument use is a key component to effective gas testing and is a critical aspect of an effective hot work safety program.

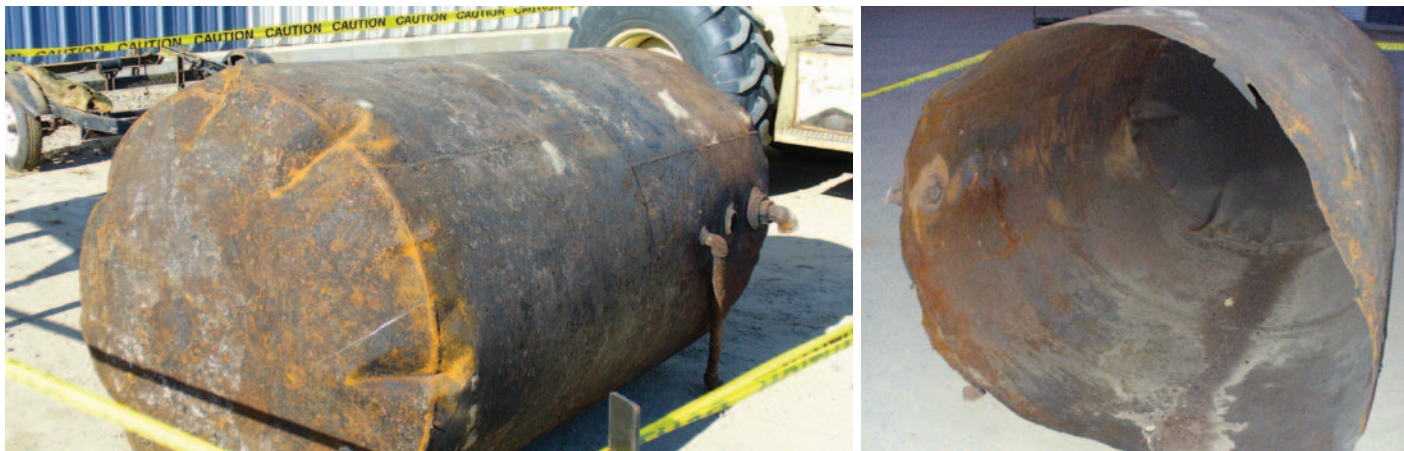
Exterior and interior views of the fuel tank involved in the hot work accident at A.V. Thomas Produce.

Two employees at A.V. Thomas Produce were using an oxygen-acetylene torch to loosen a fitting on an old fuel tank, which the company hoped to refurbish for field storage of diesel fuel. The workers, however, were unaware that the tank contained residual hydrocarbon liquid and vapor from an unknown prior use. The tank was not cleaned or purged before work began. Shortly after applying heat to the tank, an explosion occurred, blowing the end of the vessel off. Both employees were airlifted to a regional burn center, where they were treated for burns covering 30 to 50% of their bodies.

The facility had no formal hot work program, and no permit was issued for the hot work being performed. No combustible gas testing was performed prior to commencement of the hot work; the company did not have a policy that required it. In addition, many workers were mono-lingual Spanish speakers and had not been trained on safe hot work procedures or on the proper use of gas detectors in their native language.

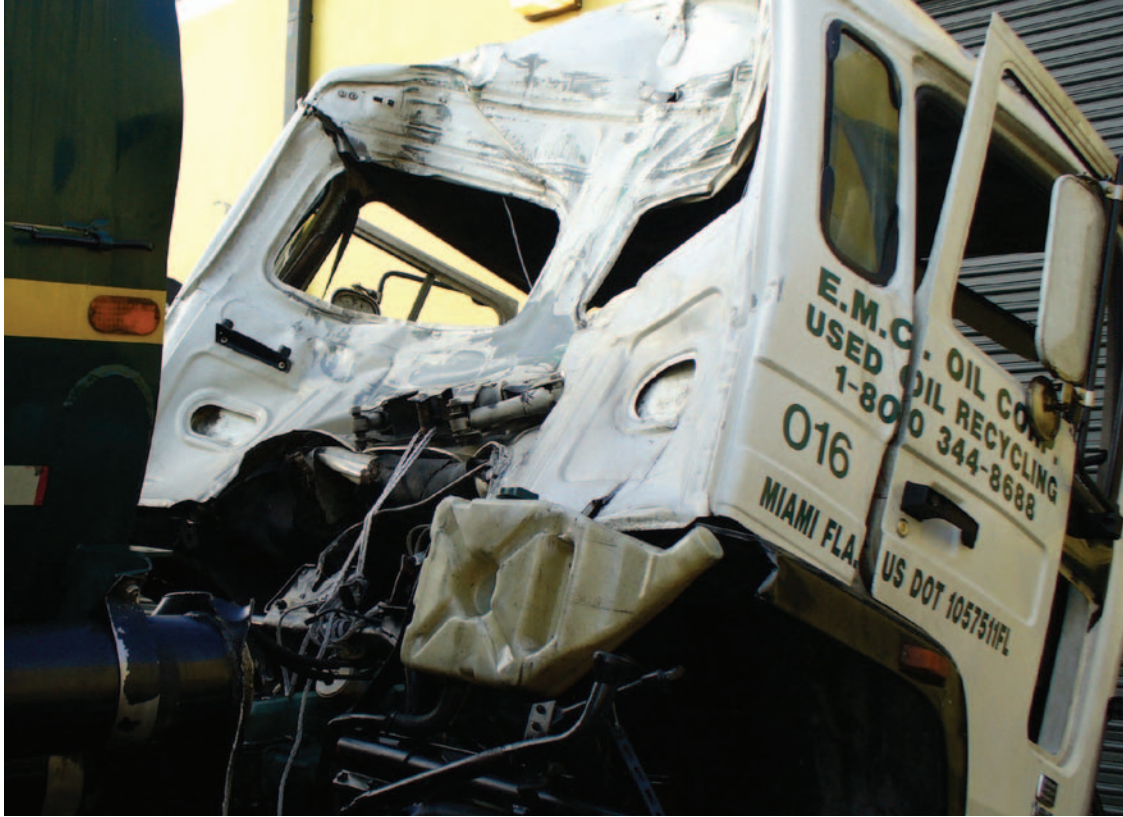
Damage to an oil tanker sustained from the December 2, 2008, explosion at EMC Used Oil Corporation.

An explosion killed a contract welder who was repairing a two-compartment oil tanker and injured another worker at the EMC Used Oil facility. The welder was in the process of welding transfer piping onto the tanker when residual hydrocarbon vapor from the 2,500-gallon rear compartment ignited, causing a powerful explosion.

The surviving worker stated that the contractors did not perform combustible gas monitoring and relied upon the host company to assure that tanks were safe for hot work. However, EMC indicated that it relied on contractors to monitor for gas; although the company owned a multiple gas detector, it was used only for confined space entry. EMC did not have a formal hot work permitting or authorization system.

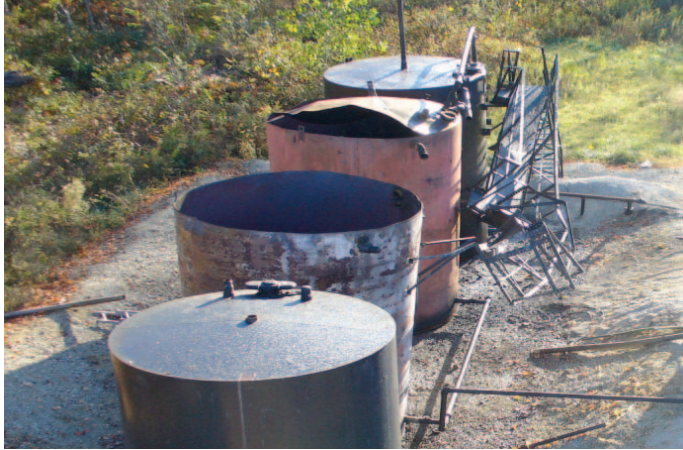
Oil storage tanks involved in fire and explosion at MAR Oil.

An explosion killed two contract workers while they were welding above a series of three interconnected crude oil storage tanks at a MAR Oil site. The explosion occurred when the workers attempted to weld a bracket on top of one of the tanks, near an atmospheric vent. Because the tanks were interconnected, oil flowing into an adjacent tank likely displaced flammable vapor into the tank being welded. The vapor escaped through the vent and was ignited by welding sparks.

The CSB investigators found that combustible gas monitoring was not performed prior to or during the welding. There is conflicting evidence as to whether or not the welding job was authorized by the host company. MAR Oil lacked a formal hot work program that required the hot work be identified in a written permit and be authorized by a person responsible for hot work management. The company had no formal program to select or oversee contractors, and the two contractors lacked documented training on safe hot work practices.

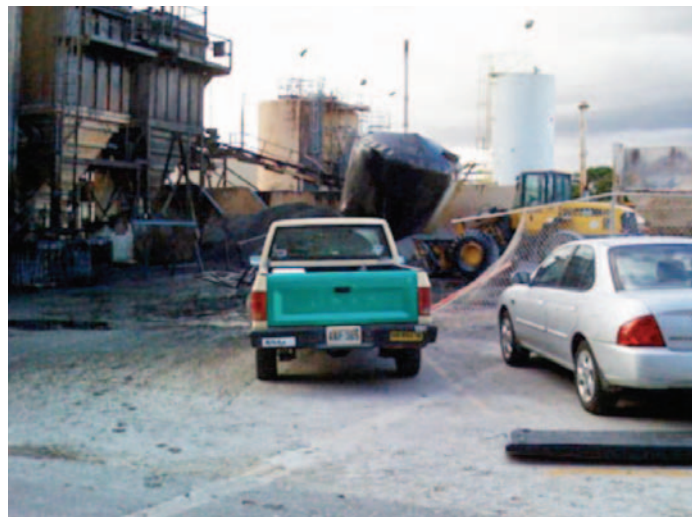
View of Philip Services Corporation following a October 7, 2008, waste oil storage tank explosion.

A contract welder was killed while welding on a catwalk located over a 9,300-gallon waste oil storage tank at the Philip Services Corporation (PSC). Following an investigation, the Honolulu Fire Department (HFD) concluded that, during the welding, sparks dropped in and around the vent area of the tank. The contents of the tank ignited, resulting in an explosion and fire. The force of the explosion hurled the contract welder about 120 feet, fatally injuring him. Three others were injured, and the tank was thrown about 30 feet.

According to the HFD investigation, a PSC official asserted that the contractors were not authorized to weld within the dike area surrounding the tank, a hot work permit had not been issued for the welding, and combustible gas monitoring was not conducted. Conversely, the contracting company's personnel asserted that they believed that the work was authorized and that PSC had conducted combustible gas monitoring prior to the welding activity.

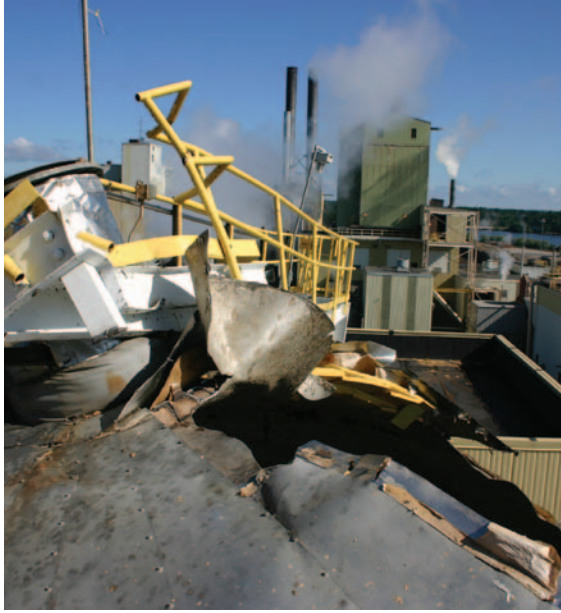
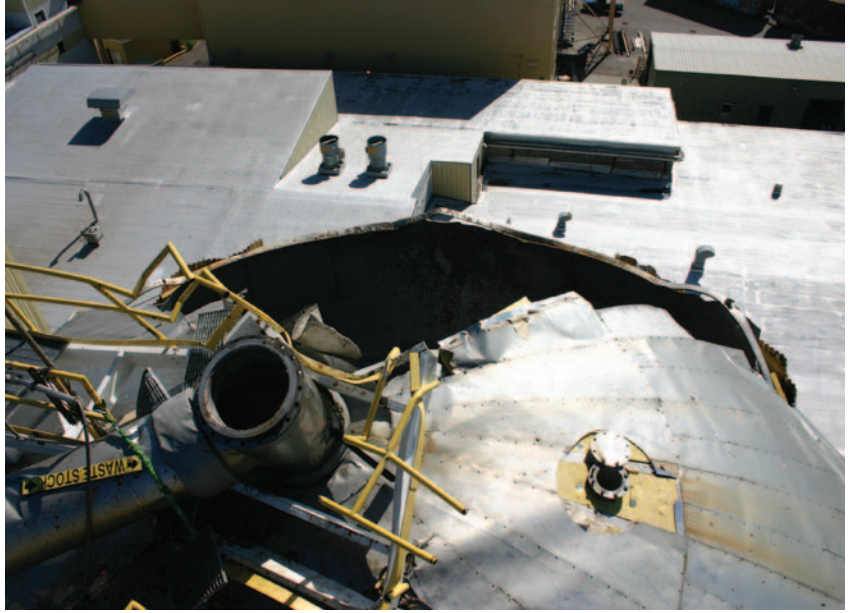
Views of the storage tank involved in the 2008 explosion at Packaging Corporation of America.

Three workers were killed in an explosion at the Packaging Corporation of America (PCA) fiberboard manufacturing facility while they were welding on a temporary metal clamp to stabilize a damaged flange connection. The flange was located on top of an 80-foot tall storage tank that contained recycled water and fiber waste.

Facility personnel were unaware of the potential presence of flammable gas from the decomposition of the organic material in the tank, and combustible gas monitoring was not typically required or performed prior to starting work. At the time of the accident, three workers were on a catwalk above the tank; one began welding the flange into place when sparks from the welding ignited flammable vapors inside the tank. The resulting explosion ripped open the tank lid, knocking two of the workers to the ground 80 feet below. All three workers died of traumatic injuries. A fourth worker, who had been observing the work from a distance, survived with minor injuries.

The CSB analysis of the tank contents determined that anaerobic bacteria had multiplied inside the tank and water recycle system over time, feeding on organic waste material. The bacteria likely produced hydrogen, a highly flammable gas, which ignited during the welding work. The CSB found that at the time of the incident, PCA supervisors and workers were unaware of the risks of flammable gas production from anaerobic bacteria growth. PCA did not perform a hazard analysis or recognize fiber waste tanks as potentially hazardous. Combustible gas monitoring was not required for the work.

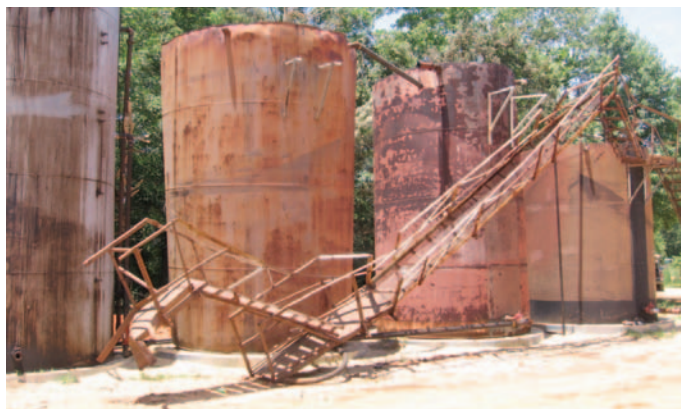
Tanks involved in the 2006 accident that killed three workers at the Partridge-Raleigh Oilfield.

On June 5, 2006, contract workers were installing a new pipe between two oil tanks at a rural oilfield when sparks from a welding torch ignited flammable hydrocarbon vapor venting from one of the tanks. That tank and another nearby tank exploded, killing three workers who were standing above the tanks and seriously injuring a fourth. As in the MAR Oil accident, all of the tanks were interconnected by piping and one of the tanks contained crude oil, the source of the vapor that fueled the explosions.

The workers had not performed combustible gas monitoring prior to or during the hot work, instead relying on the unsafe and unreliable practice of using a lit torch to check one of the tanks for flammable vapor. Workers did not empty or isolate the tank that contained crude oil prior to initiating hot work activities.

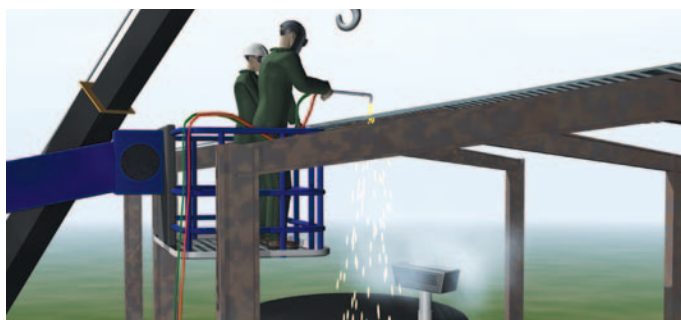
Depiction of hot work from the CSB's 2007 "Public Worker Safety" video illustrating the accident at Bethune Point.

Two workers were killed and another critically injured in an explosion involving a methanol storage tank at a municipal wastewater treatment facility in Daytona Beach, Florida. The explosion occurred while the three workers were cutting a metal roof located directly above the tank vent. Sparks showered from the cutting torch and ignited methanol vapor escaping from the vent, creating a fireball on top of the tank. A corroded and ineffective flame arrester¹⁵ on the vent allowed the fire to propagate through the device, igniting methanol vapors and air inside the tank, resulting in an explosion.

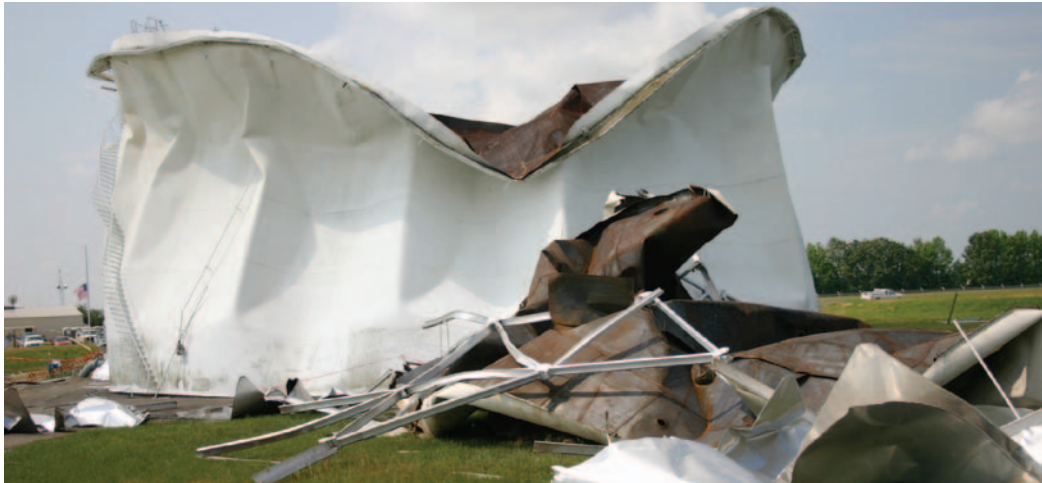
The gasoline storage tank at the TEPPCO McRae Terminal following the 2009 hot work accident that killed three workers.

Three contractors were using a cutting torch on top of the internal floating roof of a 67,000-barrel capacity gasoline storage tank at the TEPPCO Partners McRae Terminal when an internal explosion blew both the top of the floating roof and the secondary dome-shaped lid off the tank. All three were killed. The contractors were preparing to install a gauge pole. The gauge floats within the pole and measures the quantity of product within the tank. Part of the installation process involved cutting an opening into the floating roof for the pole to be inserted. The torch-cutting activity most likely ignited flammable vapor within the tank.

work permit to torch-cut the roof. The hot work permit indicated that gas testing occurred at 7:00 am, the start of the work shift. However, no documentation exists indicating that gas testing was conducted after the workers returned from lunch or when they started the hot work activities just prior to the explosion at approximately 2:30 pm. Work atmospheres can change rapidly; gas monitoring needs to be conducted immediately prior to and during hot work activities to ensure that workers are constantly aware of the potential development of an explosive atmosphere.

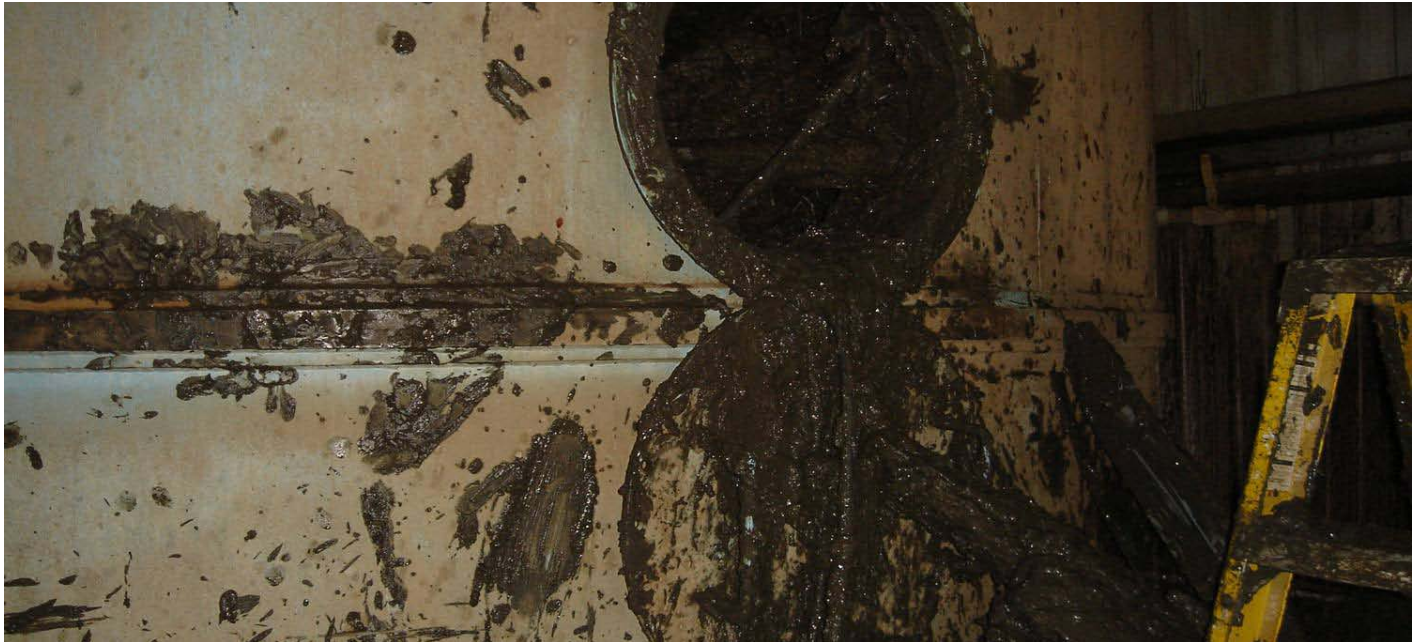
Potato-washing tank involved in the February 2009 accident at ConAgra Foods.

A welding contractor was killed while repairing a 1 ¼ by ½ inch crack on the bottom of a water clarifier tank at a ConAgra Foods facility. The 23-foot-tall tank was used to separate dirt and debris from wastewater in a potato-washing process area. The tank was open at the top and had a metal skirt around its cone-shaped base. While the welder was working inside the tank, an explosion occurred; the internal tank structures collapsed, resulting in his death.

The CSB determined that approximately 14 inches of debris-laden water had leaked through the crack in the tank and accumulated in the hidden space under the tank skirting. Examination of a sample of the liquid indicated that bacterial decomposition of the organic matter likely produced flammable gas, which was then ignited by the welding activity.

In this case, ConAgra personnel had tested for combustible gas inside the tank prior to the hot work, but only from the entrance of the tank and no flammable gas was detected. Monitoring for combustible gases was not conducted in the immediate area of the crack just prior to the initiation of the welding or in the adjacent space where flammable gas was present. Personnel were inadequately trained on the use of the specific combustible gas detector that was used and no hot work permit had been issued prior to commencing the welding.

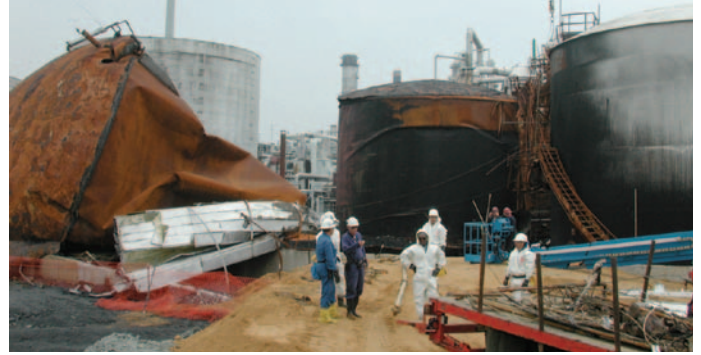
A view of the flammable storage tank involved in the accident at the Motiva Refinery.

A massive explosion destroyed a large storage tank containing a mixture of sulfuric acid and flammable hydrocarbons at the Motiva Enterprises Delaware City Refinery. One contract worker was killed, eight others were injured, and sulfuric acid from collapsed and damaged tanks polluted the Delaware River. The explosion occurred during welding operations to repair a catwalk above the sulfuric acid tank, when flammable hydrocarbon vapor was ignited by welding sparks. This resulted in a powerful explosion inside the tank, which had holes in its roof and shell and a deficient inerting system.

On the day of the accident, combustible gas testing was performed only at the start of the hot work, but monitoring was not conducted for the duration of the hot work activities. Throughout the five hours between the last gas test and the explosion, the ambient temperature warmed by 14 degrees. This warming increased the evaporation of hydrocarbons inside the tank, and the resulting flammable vapor leaked out the tank's holes into the work area.
